Manhole Inspection Summary

Manhole # S19M__045MH

Insp Date: **2/24/08 12:46 PM**

Location Address: **2101 christian st**

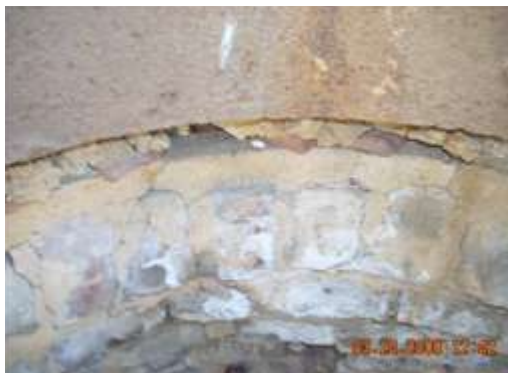
Defect 5

Condition: ☐ Sound ☐ Cracked ☐ Root Intrusion ☐ Loose Brick ☒ **Deteriorated**

deteriorated chimney/frame adjustment

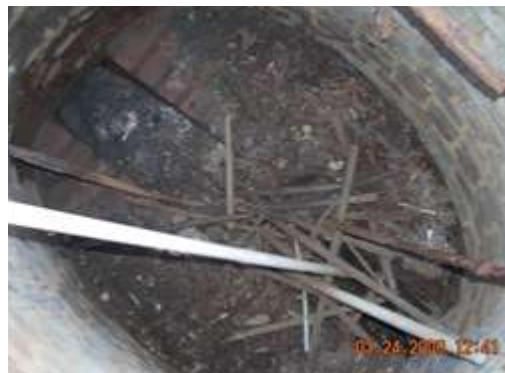
Defect 4

Condition: ☐ Sound ☐ Cracked ☐ Root Intrusion ☐ Deteriorated ☐ Leaks ☒ **Debris**

debris in channel

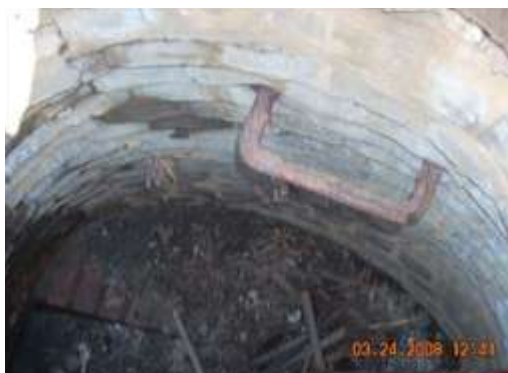
Defect 3

Count: **1** Missing: **1** ☒ **Corroded**

corroded & missing step

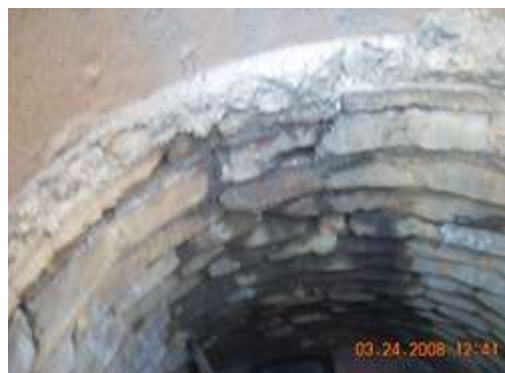
Defect 2

Infiltration: ☐ None ☒ **Joint** ☐ Cracks ☐ Mortar ☐ Roots ☐ Wall

infiltration @ chimney joint

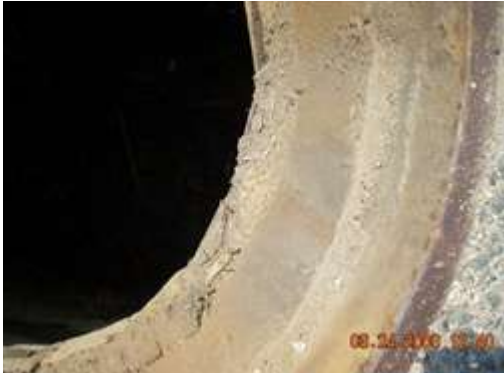
Defect 1

Offset: **2** (in.)

frame offset

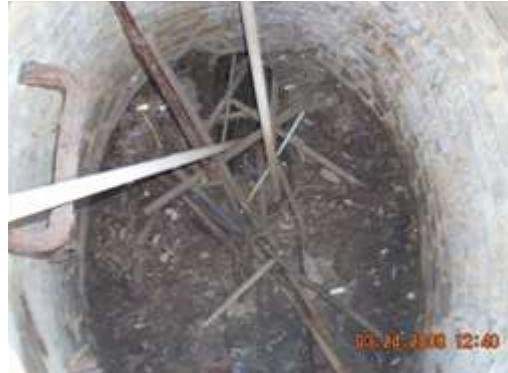
Defect 6

Condition: ☐ Sound ☐ Cracked ☐ Root Intrusion ☐ Deteriorated ☐ Leaks ☒ **Debris**

bench cond debris

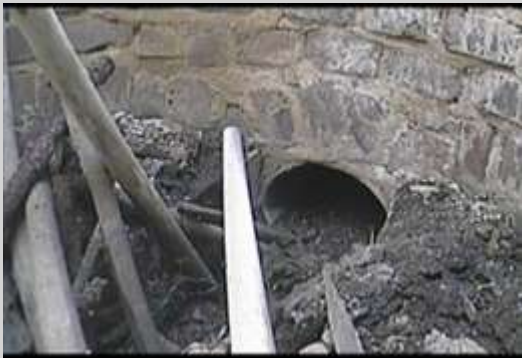
12 O'Clock Outflow

Pipe Height: **8.4** (in.) Rod and Bar (Angled)
Pipe Material: **Clay** ☐ Pipe Lined
Invert Depth: **5.68** (ft.) Flow Characteristics: **None**
Deposits: ☐ None ☒ **Mud** ☐ Sludge ☒ **Debris** ☐ Grease
Silt Depth: **3** (in.) Deposits Extent: **Medium**
Infiltration: **None** Pipe Seal Cond: **Sound**

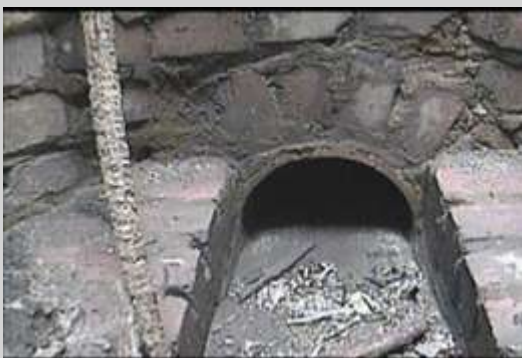
6 O'Clock Inflow

Pipe Height: **8.4** (in.) Rod and Bar (Angled)
Pipe Material: **Clay** ☐ Pipe Lined
Invert Depth: **5.19** (ft.) Flow Characteristics: **None**
Deposits: ☐ None ☒ **Mud** ☐ Sludge ☒ **Debris** ☐ Grease
Silt Depth: **4** (in.) Deposits Extent: **Medium**
Infiltration: **None** Pipe Seal Cond: **Sound**
